# Palmyra Museum from 2015 to 2025: an analysis of the destruction trajectory, documentation efforts, protection of cultural heritage amid conflict, and prospects for recovery

**Abstract:** In this study, the management and condition of the Palmyra Museum during and after the Islamic State's (ISIS's) control of the site in May 2015 are examined. The extensive damage inflicted on the museum's collection is highlighted, while the proactive emergency measures taken to protect its holdings are also emphasized. Thanks to the efforts of the Directorate-General of Antiquities and Museums (DGAM), a significant number of statues and artifacts were successfully transferred shortly before the city fell, effectively mitigating potential losses. Following Palmyra's recapture in March 2016, preservation efforts were redirected toward the remaining objects, leading to additional evacuations. By December 2016, the museum was nearly empty when it came under ISIS control once more. In a positive development, a 3D digital record of the site was created by the French firm Iconem. At the invitation of the Directorate-General of Antiquities and Museums (DGAM), a Polish archaeological team joined its Sy

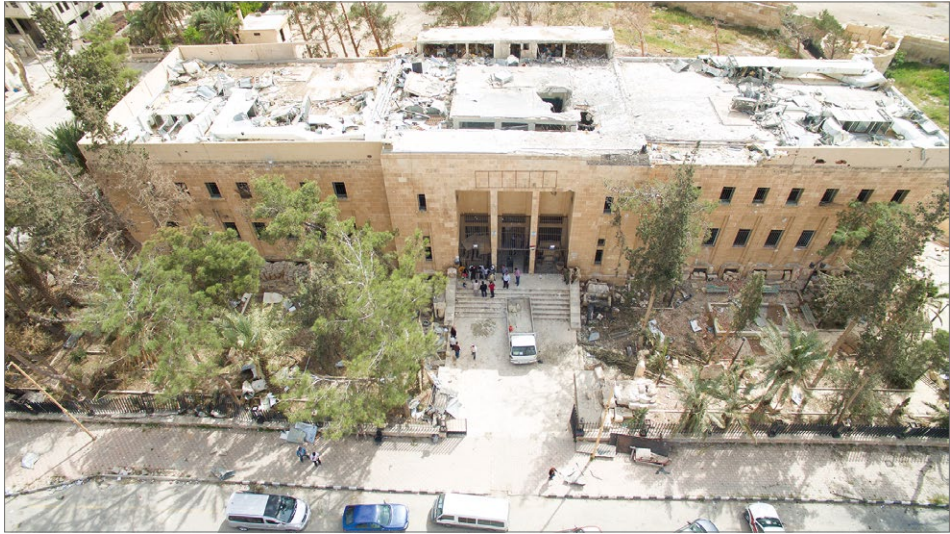
Fig. 3. The façade of the museum after the destruction (Photo H. Saad)

struction. After ISIS took control, satellite imagery revealed unusual activity around archaeological sites and within the museum complex, raising concerns that the remaining cultural treasures were at risk of damage and destruction (Al-Asaad 2016; Abdulkarim and Seigne 2024) [Figs 3–4].

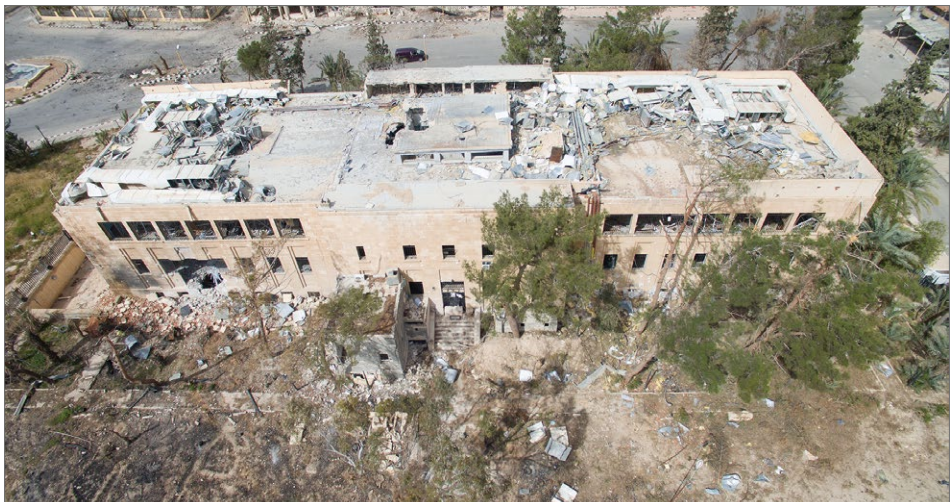
Fig. 4. The rear of the museum after the destruction (Photo H. Saad)

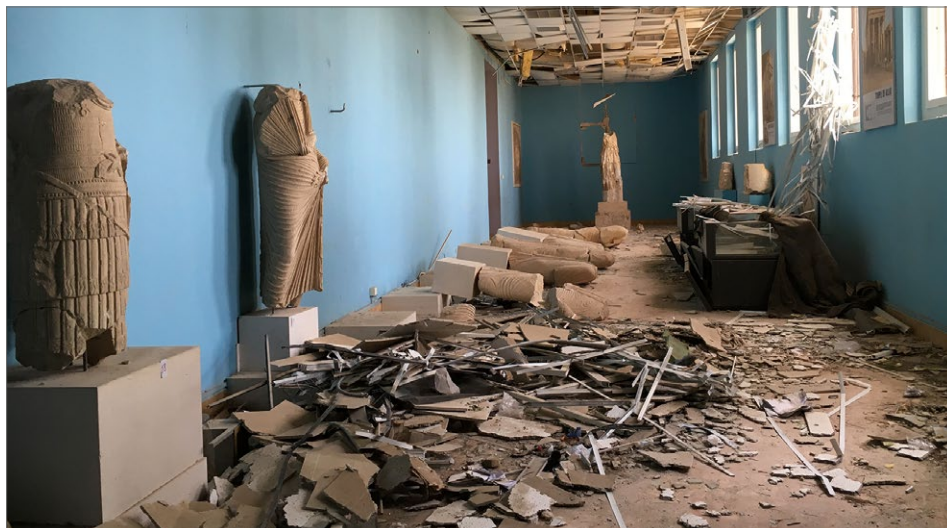
Fig. 5. Damage in the Palmyra Museum during the ISIS occupation (Photo M. Abdulkarim)

suffered extensive and deliberate damage, particularly to its large immovable artifacts and permanent displays. Many objects that could not easily be transported, such as funerary beds and numerous statues, were left in situ because of the extremely limited time available before the city fell [Figs 5–10].

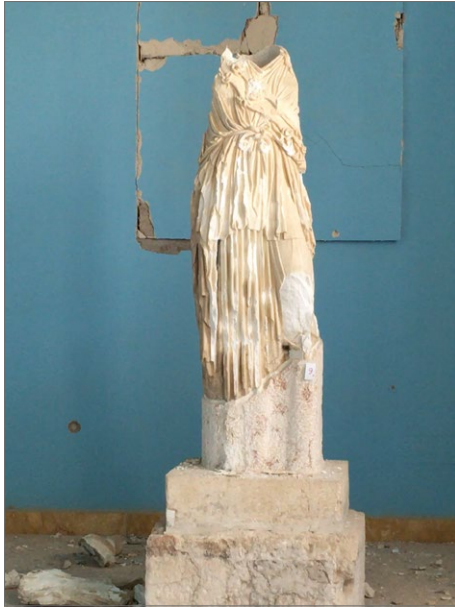
Fig. 6. Damage to the statue of Athena in the Palmyra Museum (Photo M. Abdulkarim)

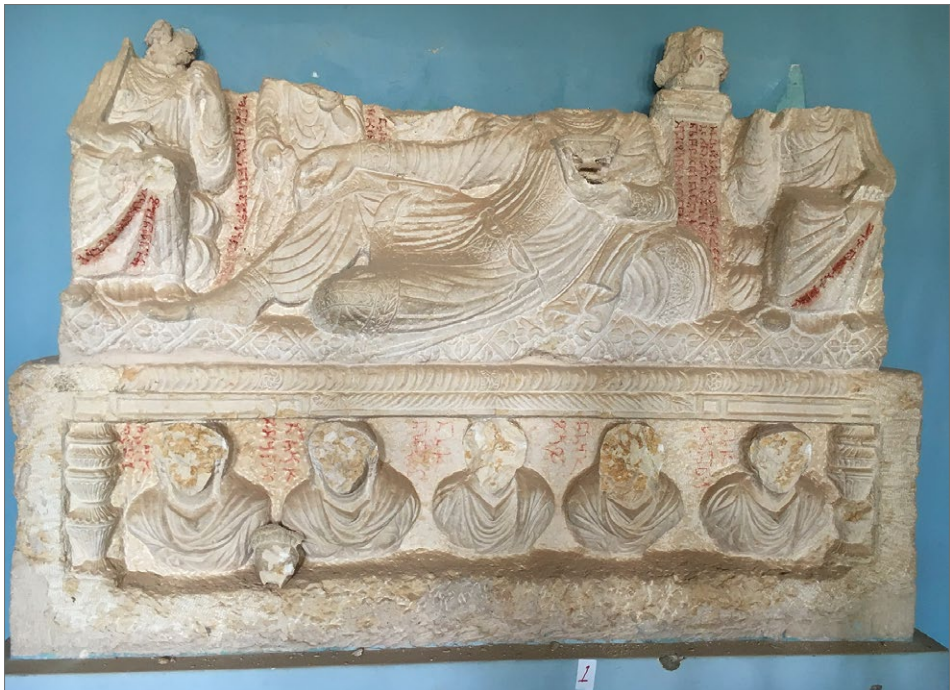
Fig. 7. Example of damage in the Palmyra Museum during the ISIS occupation (Photo M. Abdulkarim)

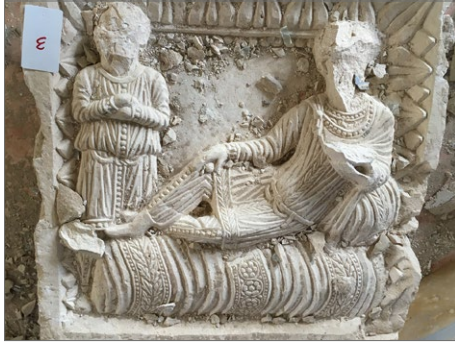
Fig. 8. Example of damage in the Palmyra Museum during the ISIS occupation (Photo M. Abdulkarim)

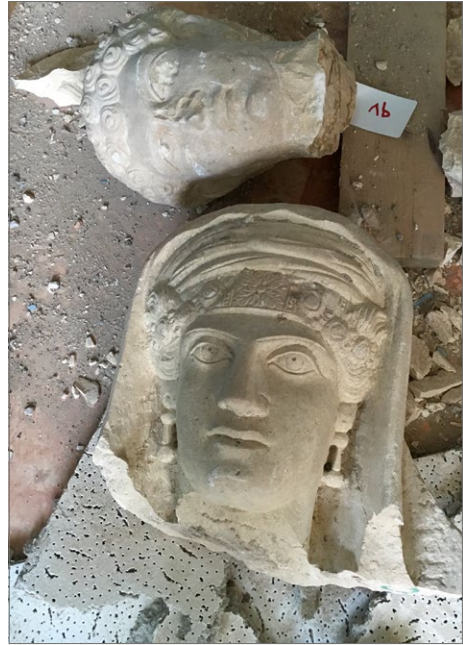
Fig. 9. Example of damage in the Palmyra Museum during the ISIS occupation (Photo M. Abdulkarim)

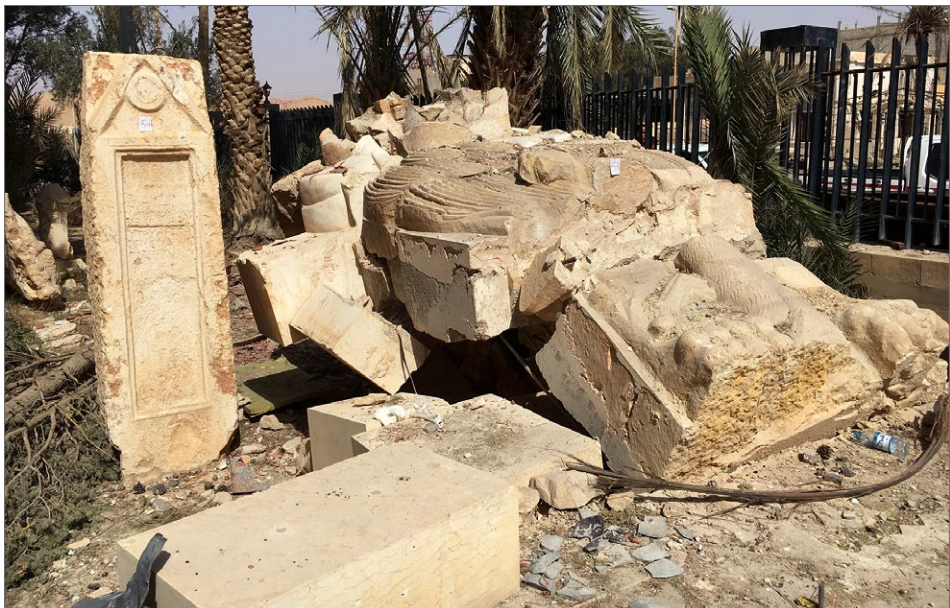
Fig. 10. Damage to the Lion of Al-Lāt in the Palmyra Museum during the ISIS occupation (Photo M. Abdulkarim)

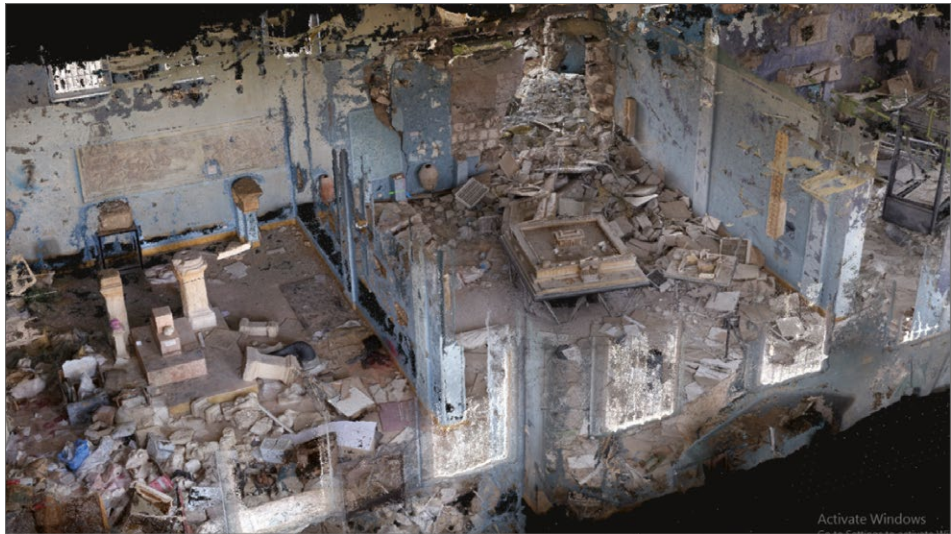
Fig. 11. 3D documentation of the Palmyra Museum after its recapture in 2016 (Iconem | photo Y. Ubelmann)

A comprehensive 3D model of the museum was produced using digital photogrammetry. This process involved capturing a dense set of overlapping

high-resolution photographs throughout the damaged galleries, thereby creating a detailed photographic survey of the building’s interior and exterior and of all surviving artifacts. The images were processed with specialized software, Agisoft Metashape, which generated accurate 3D meshes and textured models. The principal objective was to record the museum’s condition comprehensively in order to support future restoration planning. As a result, a detailed digital record of the museum was preserved before any restoration work or relocation of artifacts took place (Stott 2016) [Figs 11–14].

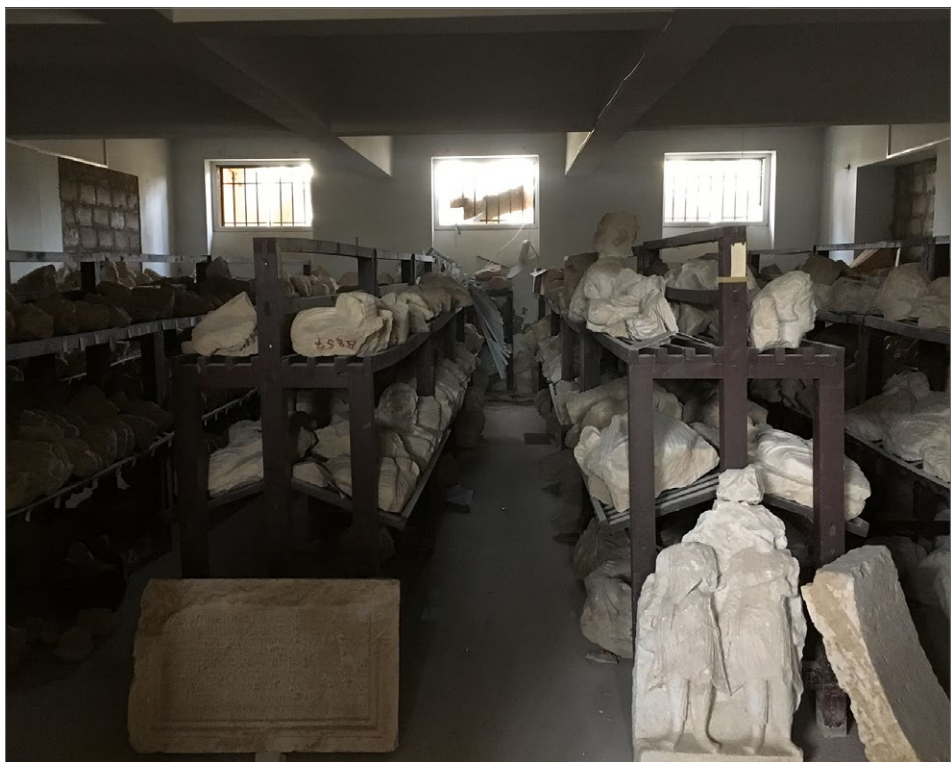
Fig. 12. Condition of the warehouse at the Palmyra Museum after the first recapture in 2016 (Photo M. Abdulkarim)

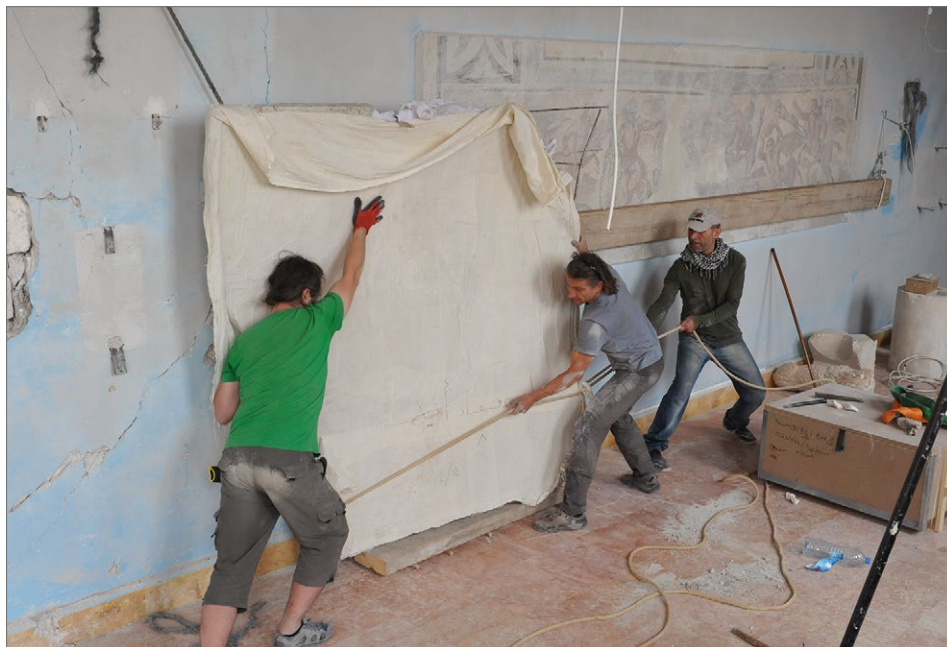
Fig. 13. Evacuation of artifacts with the participation of members of the Polish archaeological mission in 2016 (Photo DGAM Archive)

Following completion of this detailed documentation phase, the DGAM initiated the second stage of the evacuation process in April and May 2016. The remaining artifacts were carefully transferred to the

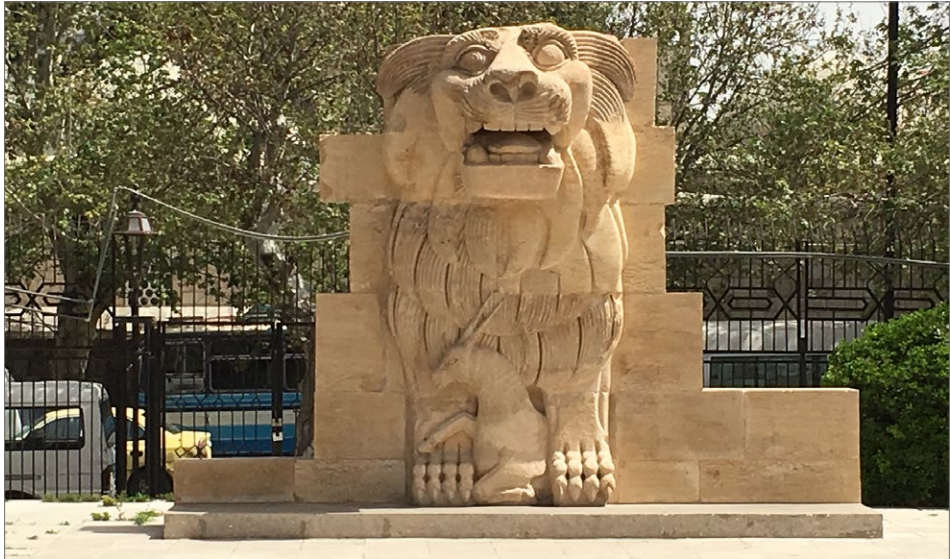
Fig. 15. The restored Lion of Al-Lāt statue on display at the National Museum of Damascus in 2017 (Photo M. Abdulkarim)

Temporary conservation treatments were employed that emphasized the preservation of authenticity and the structural integrity of the artifacts. Among the items restored was the statue of the Lion of Al-Lat, which had been severely vandalized during the ISIS occupation of Palmyra. The painstaking restoration was carried out by the Polish conservator Bartosz Markowski with financial support from UNESCO (2017). The restored statue was subsequently installed in the garden of the National Museum in Damascus in September 2017, where it became a symbol of the resilience of Syria's rich cultural heritage [Fig. 15].
